# 「100%可預防」的飛航事故

本文係基於NTSB飛航事故編號ANC20MA010的最後調查報告摘要：「撞擊到地形障礙物；Safari航空公司，空中巴士AS350 B2直升機，編號N985SA；夏威夷，Kekaha山區；2019年12月26日。」以及相關文件等。

## ‘100 Percent Preventable’

### The NTSB says FAA inaction on several safety recommendations contributed to the fatal 2019 crash of an AS350 on a Hawaii mountainside

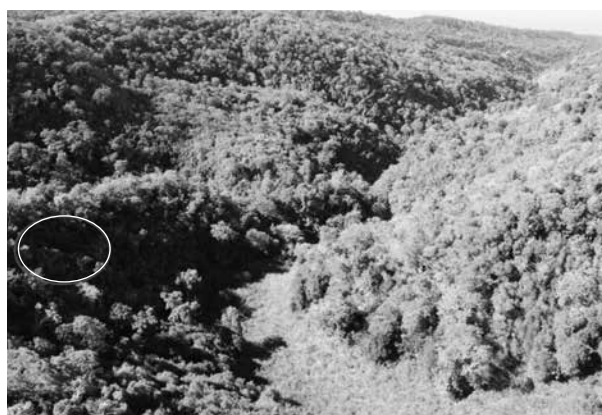
一位擁有15,700多小時飛行時間的直升機飛行員，駕駛他的AS350 B2空中巴士直升機，在夏威夷Kauai島飛進低雲和下雨的天氣中；直升機在撞擊山腰的墜毀前，飛行員失去關鍵性的目視參考，造成空中旅遊觀光的飛行中，在2019年發生直升機墜毀、飛行員和所有6名乘客罹難的致命飛航事故。

圖示：致命飛航事故現場，位於夏威夷山區一側(畫圈處)。

「然而，發生飛航事故的飛行員，決定繼續他的空中旅遊觀光航線，因而飛進了惡化的天氣，最後在直升機撞擊地形障礙物之前，失去了足夠的目視參考，」調查報告補充說：「飛行員決定繼續飛進惡化的天氣，可能是他缺乏相關的天氣資訊，以及對非典型天氣模式的認知；也有可能是，他評估飛行中的天氣狀況不準確，或是對自己的飛行能力過度自信。」

該事故調查促使 NTSB 發佈了 10 項新的安全建議，包括向 FAA 提出關於改善夏威夷飛航基礎設施的建議，以獲得持續性的無線電通信和飛行追蹤性能，才能更有效地監督夏威夷空中旅遊觀光的業者，並且要求他們：「為其機隊安裝飛行追蹤性能的裝備，以及……提供主動飛航監控的訓練有素公司與支援飛航的專業人員。」

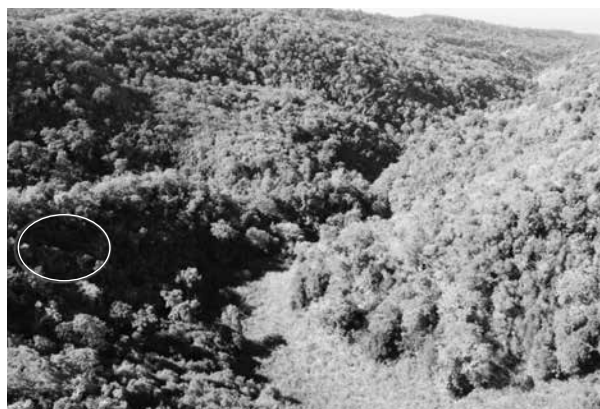
A 15,700-hour helicopter pilot flew his Airbus Helicopters AS350 B2 into low clouds and rain on the Hawaiian island of Kauai and lost sight of key visual references before the helicopter crashed into a mountainside, killing the pilot and all six passengers on a 2019 sightseeing flight. The helicopter was destroyed.

The accident site, on the side of a Hawaiian mountain, is outlined in circle.

“The accident pilot, however, decided to continue his tour into deteriorating weather, eventually losing adequate visual references before the helicopter struck terrain,” the report said, adding, that “his decision to continue the flight into deteriorating weather was likely influenced by a lack of relevant weather information and an atypical weather pattern, and it’s possible that he inaccurately assessed the weather conditions in flight or was overconfident in his abilities.”

The accident investigation prompted the NTSB to issue 10 new safety recommendations, including recommendations to the FAA regarding infrastructure improvements in Hawaii to allow for continuous radio communications and flight tracking, better surveillance of Hawaiian air tour operators and requirements that operators “equip their fleets with flight tracking capabilities and ... provide active flight monitoring by trained company flight support personnel.”
